CALSPAN ON-SITE AMBULANCE CRASH INVESTIGATION

SCI CASE NO.: CA11026

VEHICLE: 2001 FORD F350 / MCCOY MILLER TYPE I AMBULANCE

CRASH DATE: OCTOBER 2011

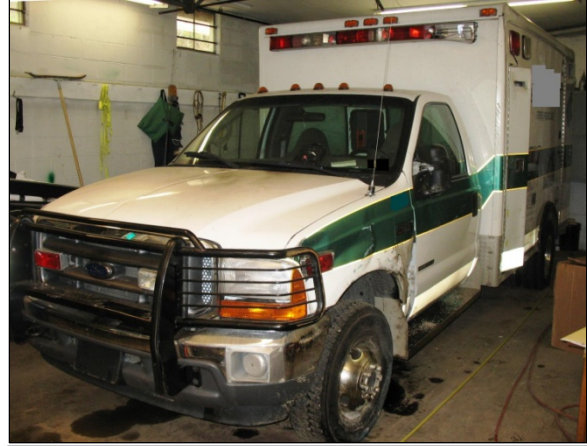
The chassis had a 422 cm (166 in) wheelbase and 4-wheel power-assisted hydraulic disc brakes with anti-lock. At the time of the SCI inspection (**Figure 3**), the vehicle's odometer reading was 160,880 km (99,966 mi). The vehicle manufacturer's recommended tire size was LT235/85R16, with recommended cold tire pressures of 400 kPa (58 PSI) front and 448 kPa (65 PSI) rear. During an interview, the ambulance agency's fleet manager reported that all six tires were replaced the previous year at the same time. Thus, at time of the SCI inspection, the vehicle was equipped with Goodyear Wrangler tires of the manufacturer's recommended size at all six axle positions, mounted on OEM steel wheels. All six tires had matching Tire Identification Numbers (TIN): MDOR Y5JV 0310. Specific tire data at the time of SCI inspection was as follows:

Figure 3: Front left oblique view of the 2001 Ford F350 / McCoy Miller Type I ambulance.

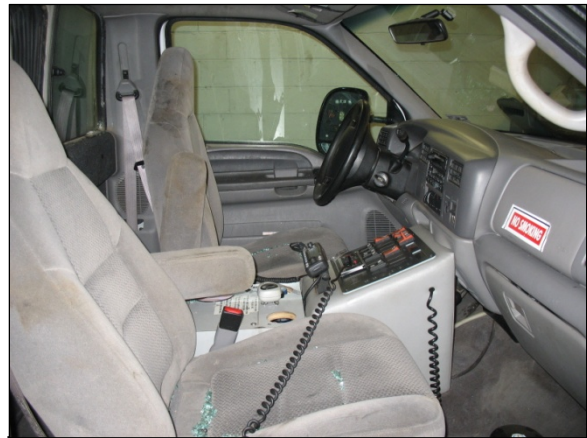
Figure 4: Interior view of the Ford chassis' cab.

Inspection of the interior of the Ford chassis' cab was unremarkable. There was no intrusion or interior damage associated with the exterior crash forces. The windshield and left front glazing were intact and undamaged; however, the right front window glazing was disintegrated. It should be noted that the ambulance agency's fleet manager reported during an interview that this damage occurred post-crash during towing and recovery efforts, and thus was not crash related.

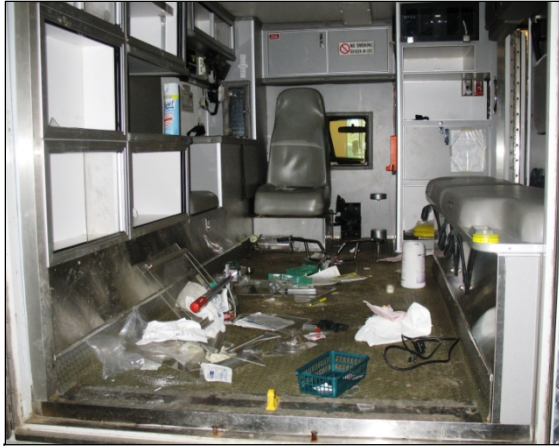
Figure 6: Interior of the ambulance's patient compartment module.

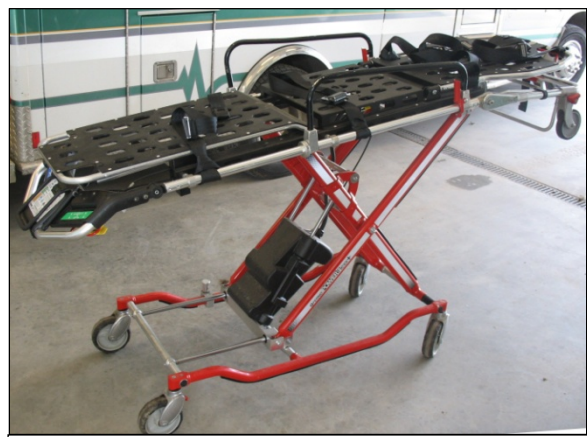
The patient stretcher was a POWERFlexx+ Power Ambulance Cot that was manufactured by Ferno-Washington Incorporated, serial number: 10N-176613. It was of all-metal construction with tubular legs aligned in an X-frame that featured power raise/lower capabilities (**Figure 11**). Electrical power was supplied by an on-board 24V lead acid DC battery pack, which could be charged automatically via the Integrated Charging System (ICS) while locked into position within the patient compartment of the ambulance or manually via an external 120V household connection.

Figure 11: The POWERFlexx+ stretcher in its raised position during the SCI inspection.

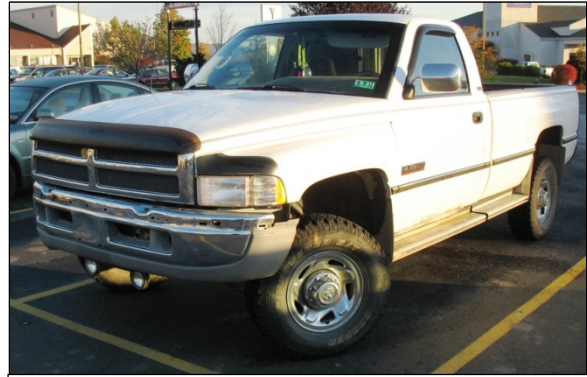
Figure 14: Left front oblique view of the Dodge.
